Intravenous fracture of a peripheral cannula at the dorsum of the hand; in a patient who used walking aids after surgery

Case Report

Keywords: Orthopedic patients, wrist, Intravenous cannula fracture

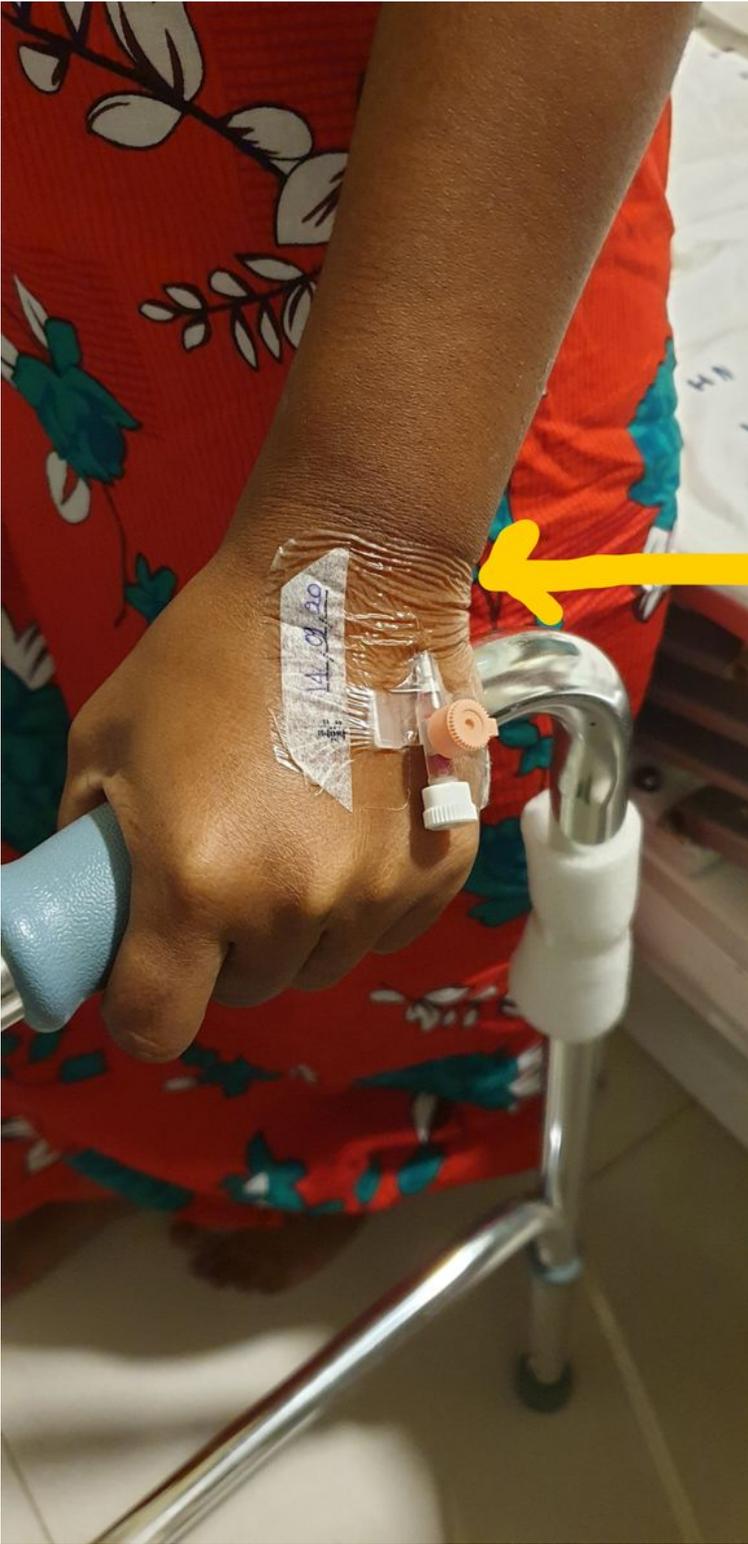
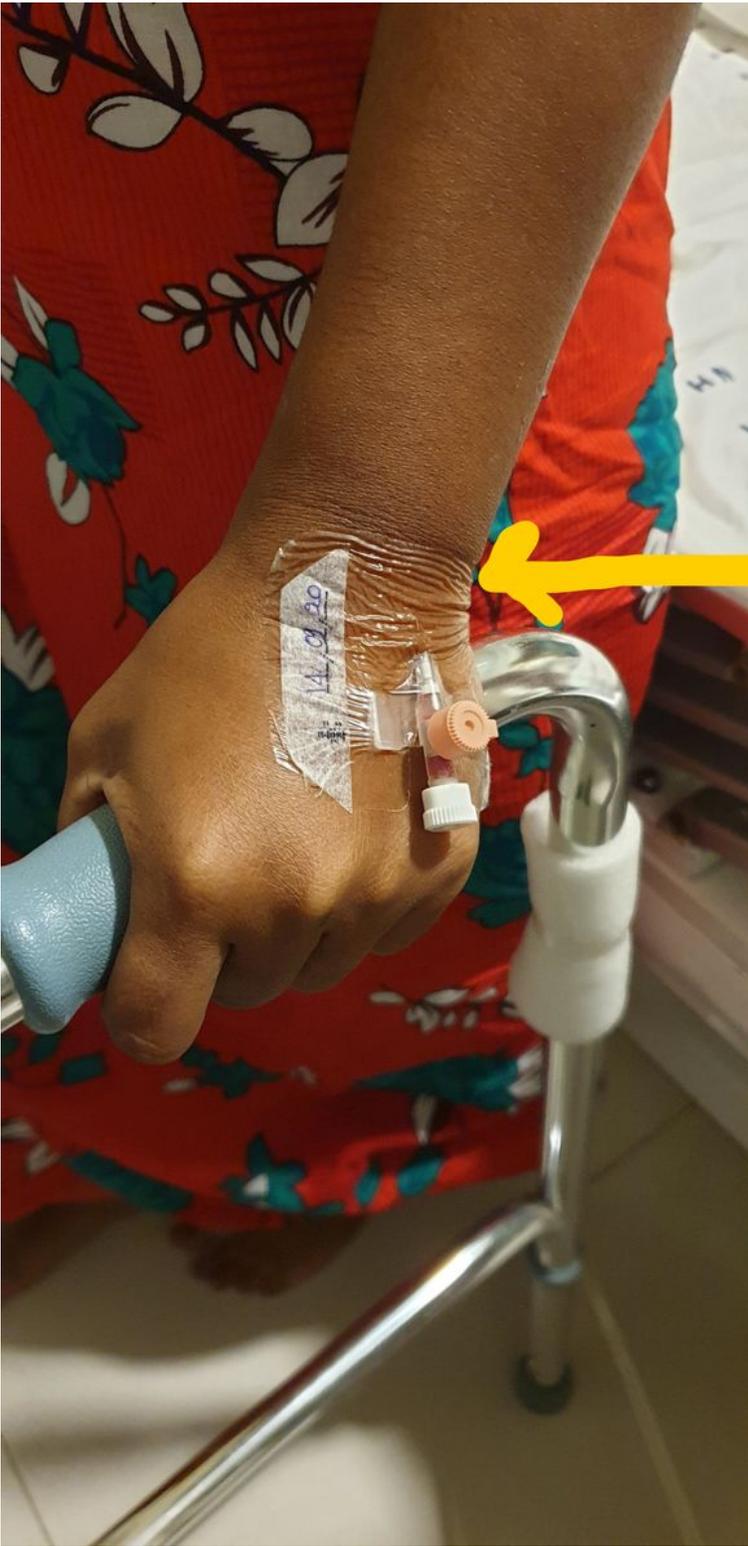
Figure 1

A 65 yrs old patient admitted to the University Hospital of the General Sir John Kotelawala Defense university for bilateral knee replacement. She admitted after all preoperative preparations for right knee replacement. She had stable vitals and all preoperative blood investigations were normal. She follows the routine procedure for knee replacement surgery. On the day of surgery in the operation theatre consultant anesthetist had placed a 17 G cannula in the basilic vein of the dorsal venous arch of the left hand(Fig.1).

Even though the outer part of the canula placed distal to the wrist, the catheter part stay intravenous across the wrist. When the patient mobilizes with a walking aid, patient's wrist get bended to hold the walking aid. When the wrist bend , the catheter portion of the IV cannula also get bended(Fig1). Due to the inherent nature of the flexibility of catheter part, canula get bended at the neck of the canula. Repeated bending of plastic catheter can result in failure of it integrity and facture of the catheter part of the canula. (Fig 2) In our patient obviously the canula was placed at the cephalic vein near the wrist. When the patient holding the walking frame, wrist is getting bended and body weight loads at wrist. It is very obvious , catheter of the canula is bended at the neck of the cannula. The frequent bending with loaded weight might have resulted in a fatigue fracture of the canula.

Cannula at the dorsum of the hand

1. When patients has to use walking aids, not to place peripheral venous cannulas at the dorsum of the hand or near the wrist joint.

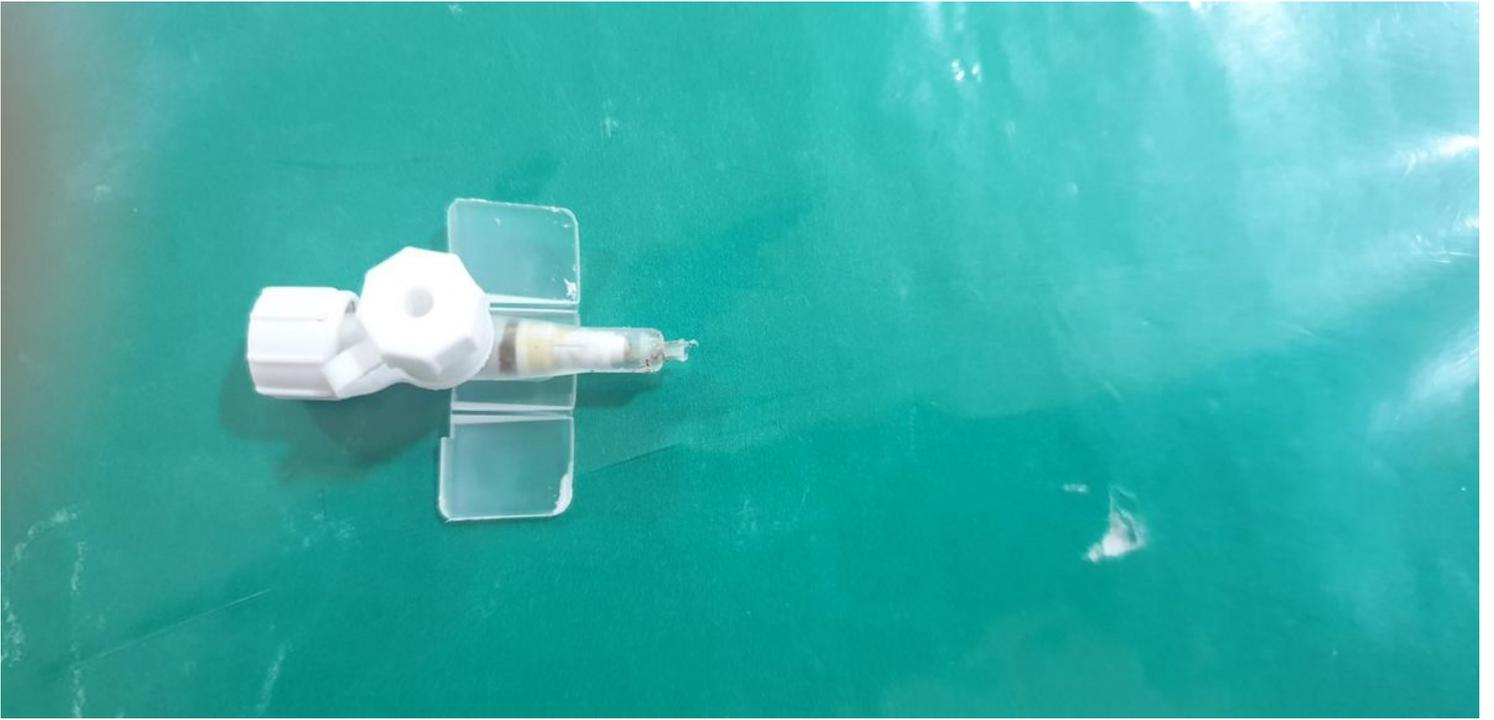
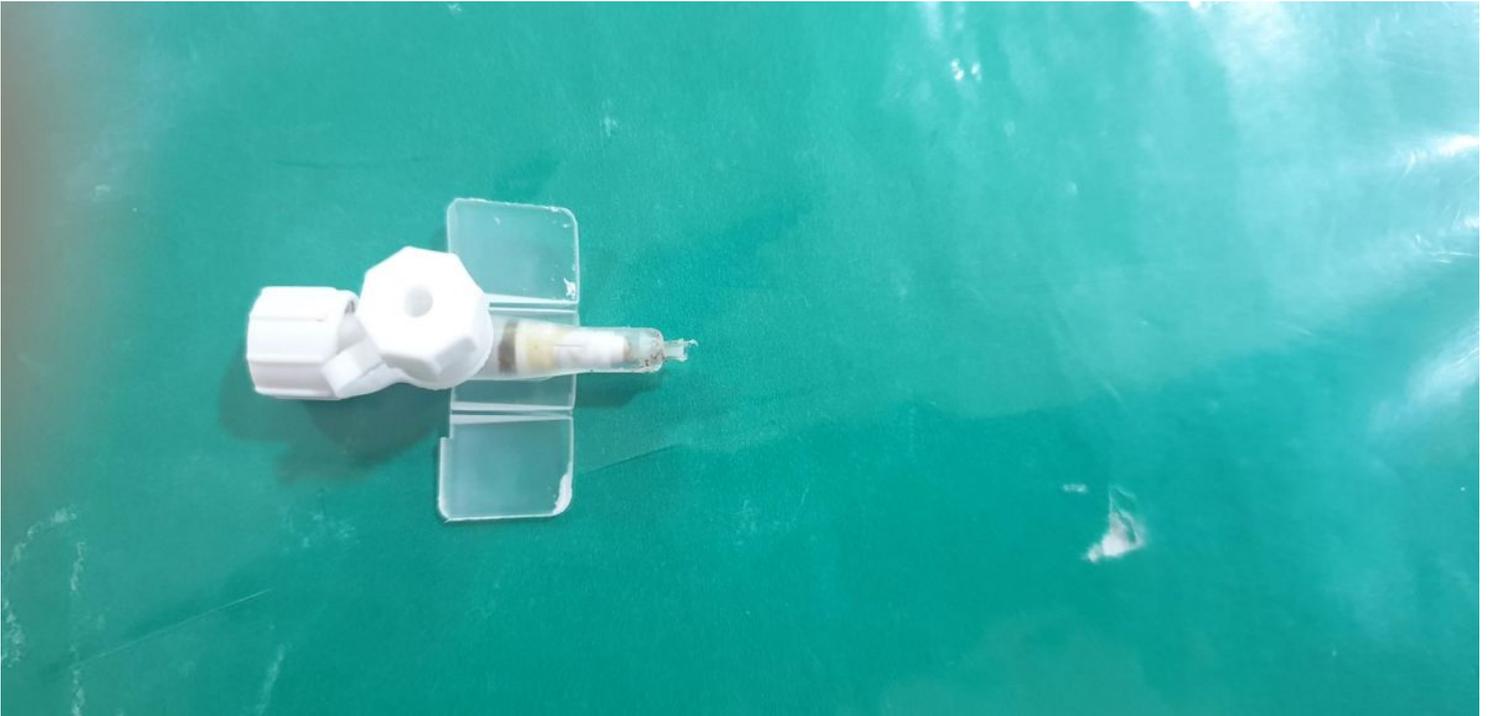
Figure 2

As the discharged was planned on day 4 , the ward nurse had removed the cannula and it was immediately recognized that the intravenous cannula portion was missing. It was noticed the IV cannula was broken at the neck of the cannula. Nurse was unable to remove the stem of the cannula. (fig 2) .

Proximal part of the fractured cannula

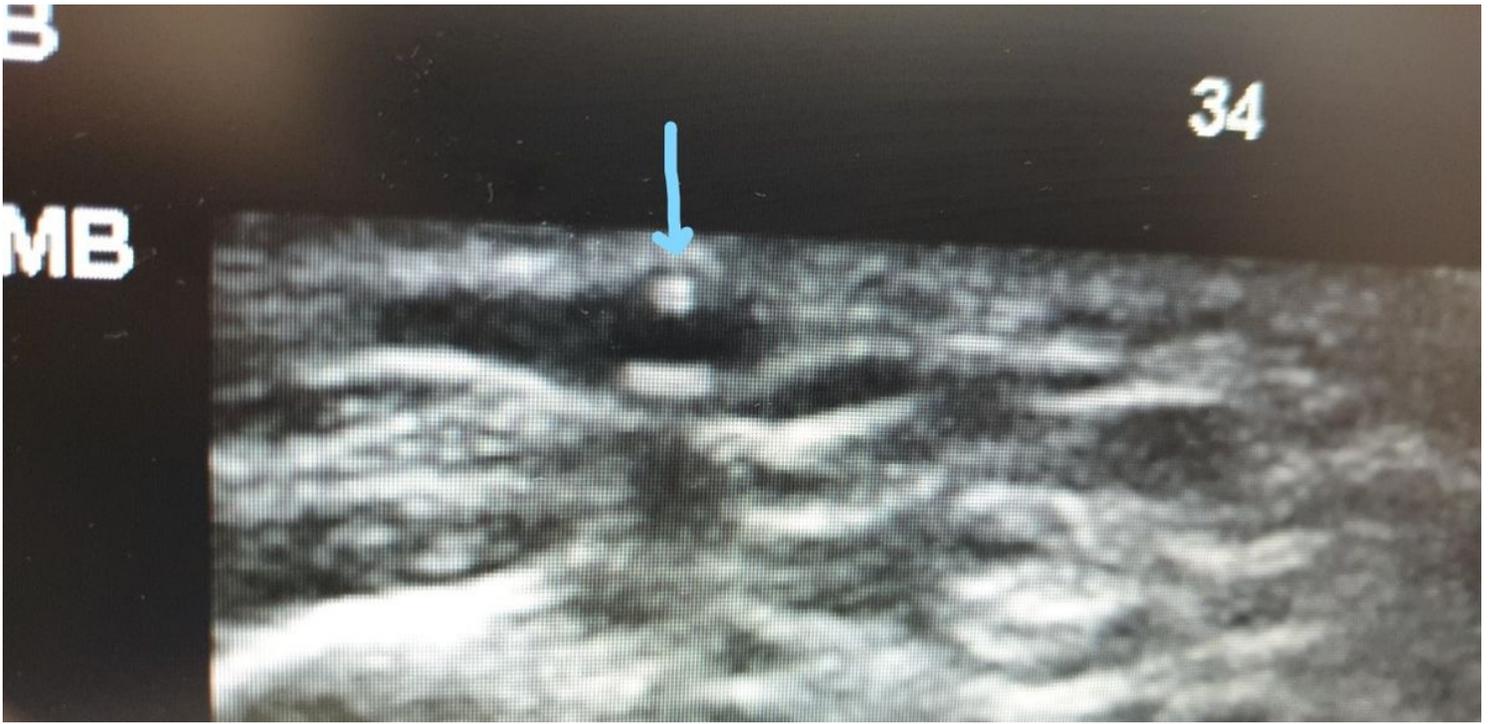
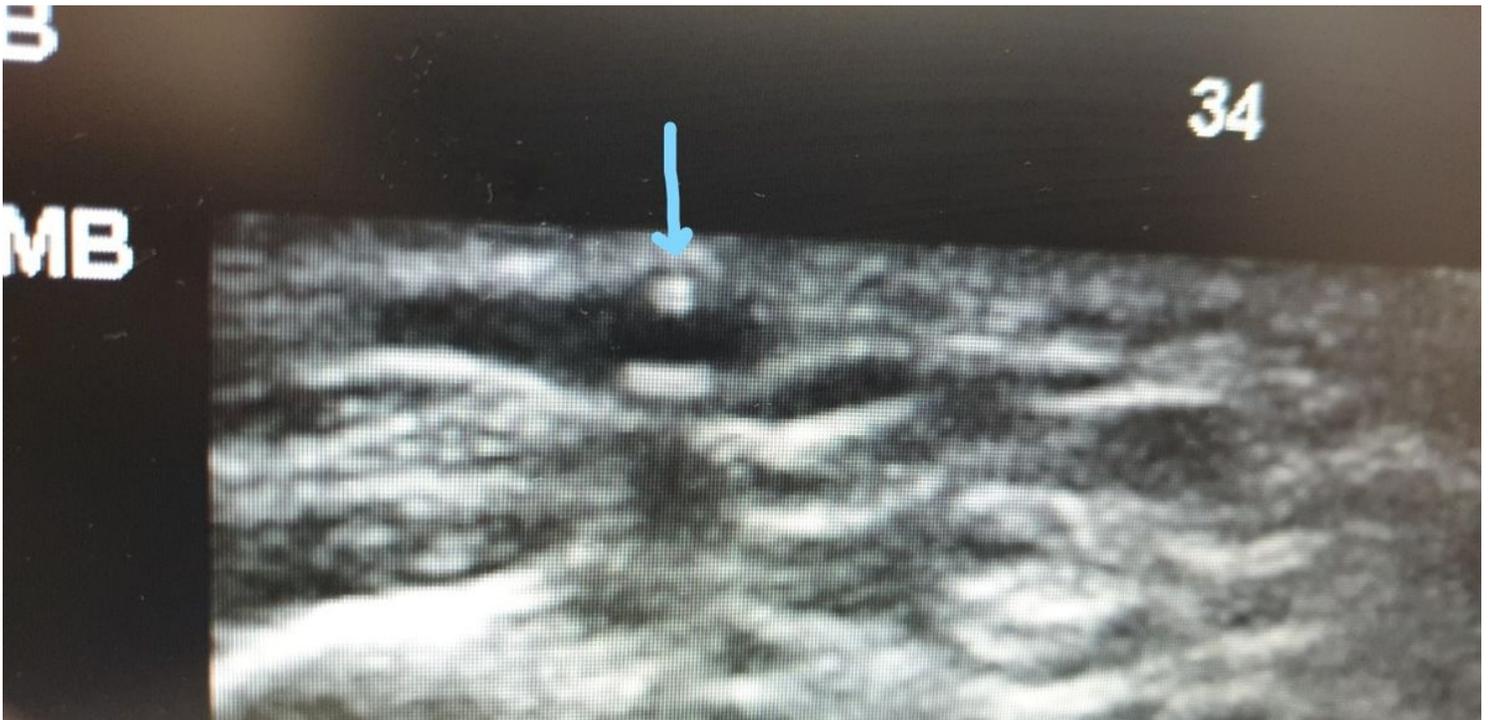
Figure 3

Immediately this was notified and instruction were given to apply a tourniquet in proximal fore arm near the elbow. Patient was taken to the operation theater and bed side ultra sound scan was performed using the bed side scanner(Fig 3). It was noted the broken piece of cannula is in the dorsal veins just 3 cm away from the point of insertion. New tourniquet tube was applied closer to the proximal end of the broken cannula part.

Ultrasound scan picture (arrow indicates intravascular part of the fractured cannula)

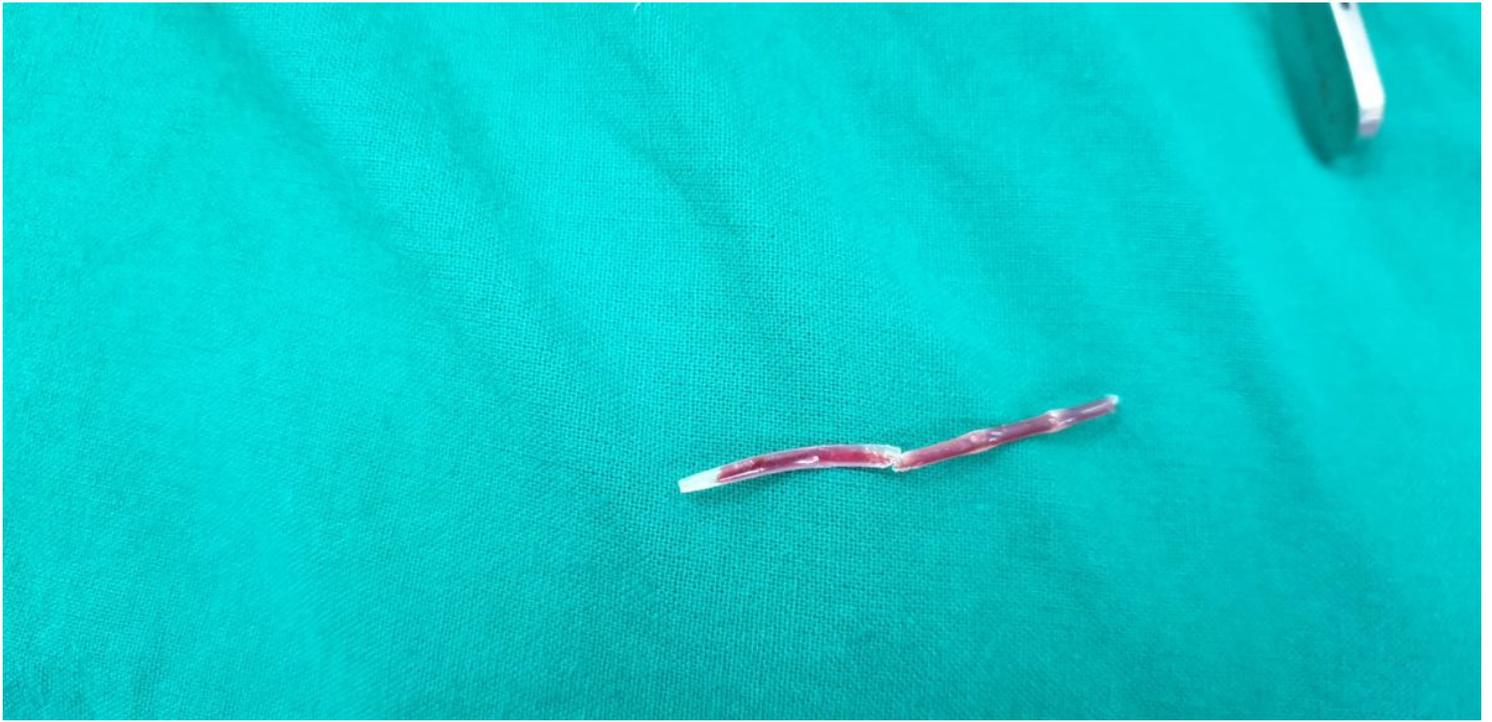
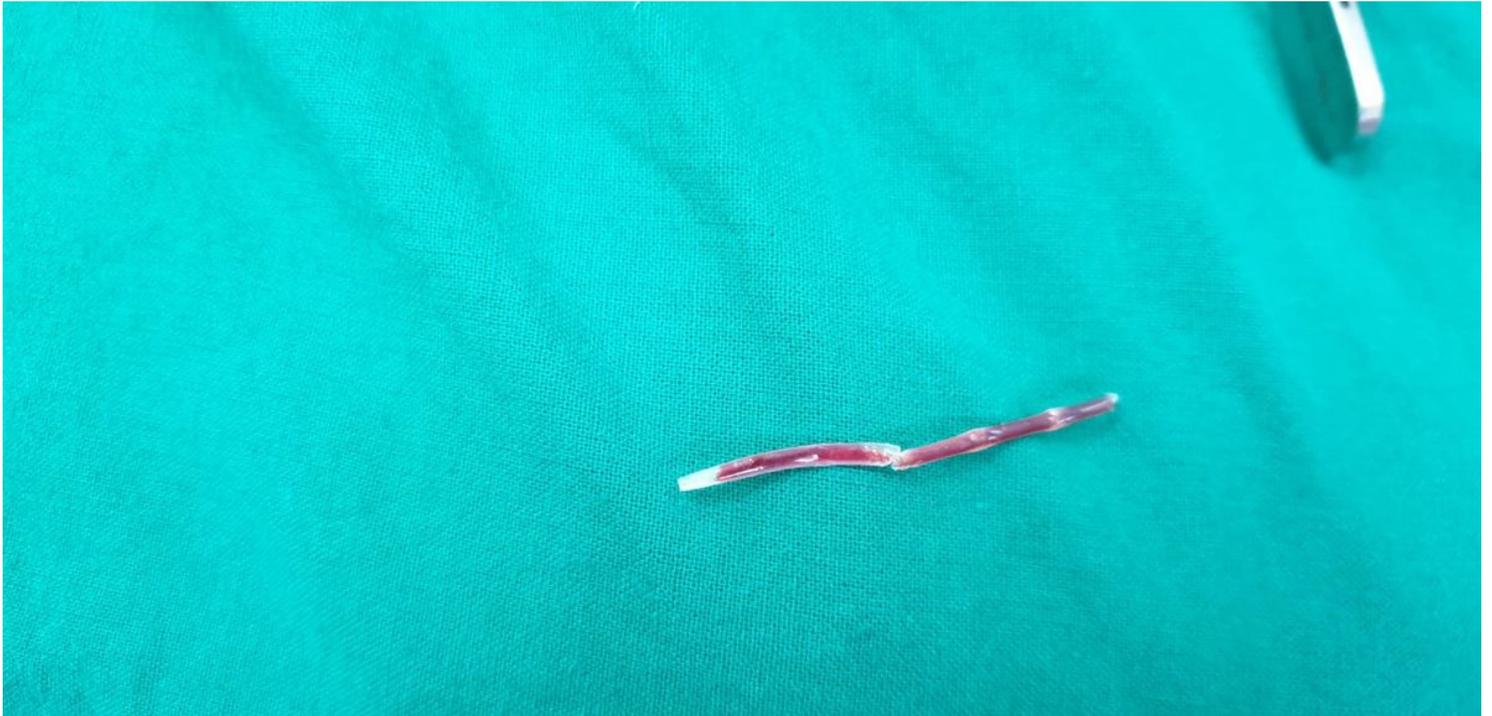
Figure 4

Intravascular part of the broken piece of the cannula

The fore arm was cleaned and draped, vein was explored under local anesthesia and transverse venotomy was done and the broken cannula part removed with a curved mosquito forceps, without any hazardous out comes(Fig 4). Both the proximal and distal ends of the vein was milked to remove the formed blood clots. The vein was ligated. Skin was sutured with 3.0 Ethylone. The patient made an uneventful recovery and was discharged with follow-up plan for post total knee arthroplasty.
