Photo 1. Cylindrical frame infiltration test

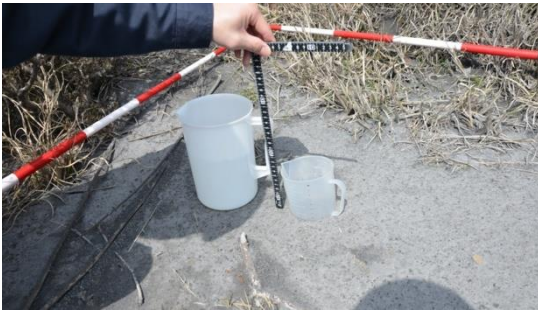
Note: (a) Cylindrical frame container used for the test, (b) Inserting the container into the volcanic ejecta, (c) State of the survey area in the outer forest plain, (d) Expansion of the volcanic ejecta in the outer forest plain, (e) State of the survey

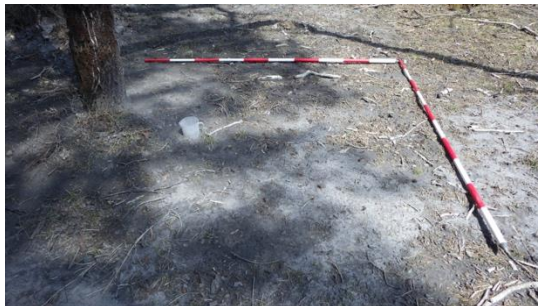
(e)

area in the forest plain, (f) Expansion of the volcanic ejecta in the forest plain, (g) State of the investigation site in the forest talus, (h) Expansion of the volcanic ejecta in the forest talus
