Study on tsunami-resistance of a reinforced soil wall based on water tank experiment

Keywords: Earthquake, Tsunami, Reinforced soil wall, Water tank experiment

Abstract

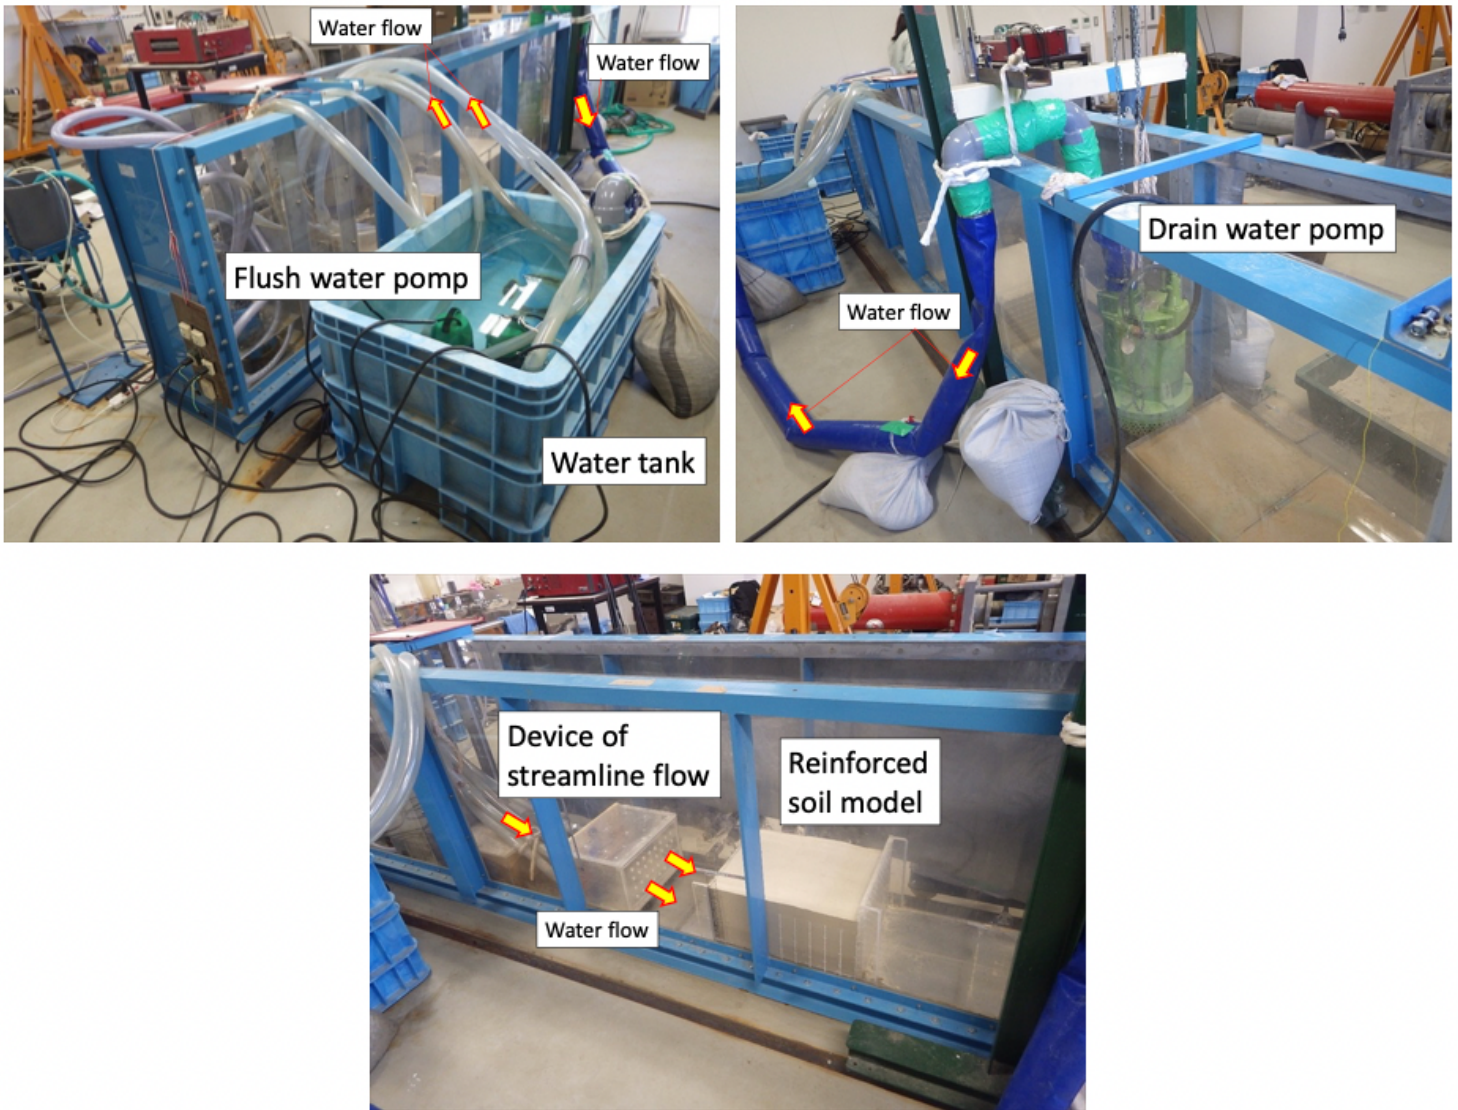
Figure 2

Overview of water tank experiment device (Left, Flush water pump; Right, Drain water pump; Bottom, Reinforced soil model)

A schematic diagram of the experiment device is shown in Fig. 1. The experimental device overviews are shown in Fig. 2. In general, the retaining wall popular height domestically is 3 m to 18 m (JRA, 2012), the height of retaining wall was supposed 10 m in our experiment. The experiment device scale was 1/40. Table 1 shows the comparison between real scale and model scale. The scale of the model was determined according to the similarity law under the 1G field, and the velocity of the water flow was determined according to the Froude similarity rule. Installing a partition made of an acrylic plate in the center of the experiment device, a model of reinforced soil wall was built. A clearance of 5 cm was set between the bottom surface of the reinforced soil wall model and the bottom surface of the water tank. A water flow pump was installed in front of and in the rear side of the reinforced soil wall so that the water flow at a constant speed could continue to act from the front face to the back face of the reinforced soil wall.

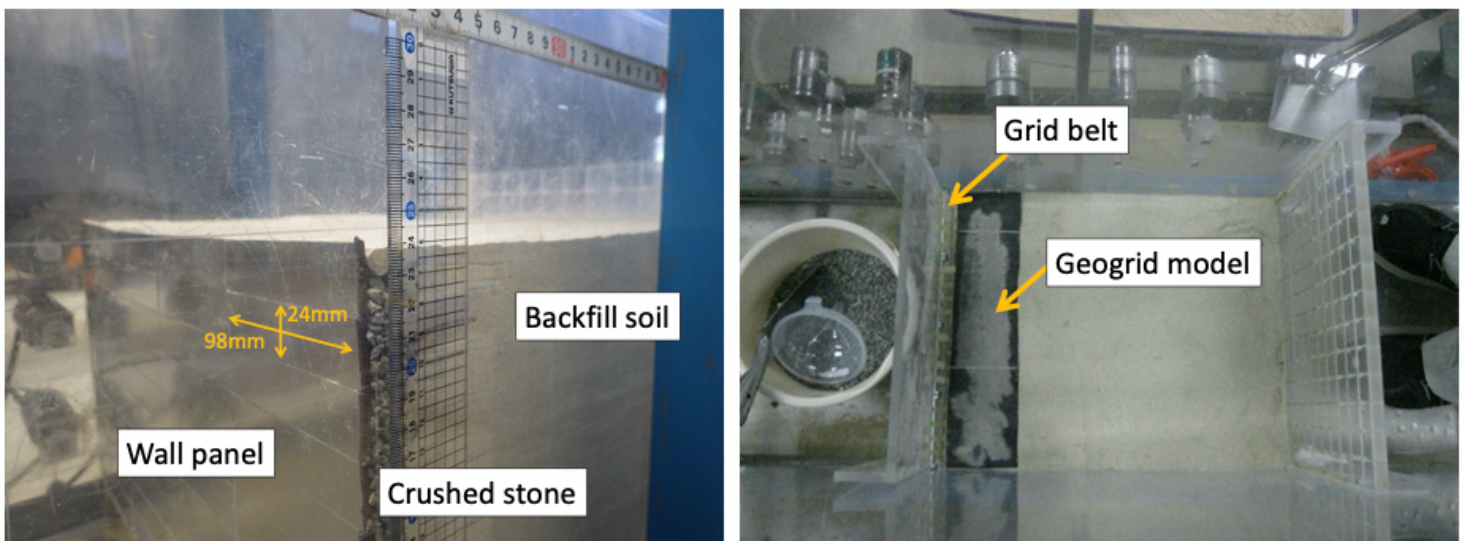
Figure 4

Overview of reinforced soil wall model (Left, Wall panel and backfill soil; Right, Grid belt and Geogrid model)

A cross section of reinforced soil wall model is shown in Fig. 3, and overviews of soil wall model are shown in Fig. 4. For the wall panel, aluminum plates with a width of 98 mm and a height of 24 mm were adopted, which was one piece having a proven track record in the previous experiment (Tsuji et al, 2011) on a reinforced soil wall having the same structure. It was supposed that the wall surface panel did not transform and adjusted only weight of the panel in consideration of model scale. Considering the scale of the model from the actual weight of the wall panel (3.05 kN/m^2), the plate thickness of the model panel was adjusted so that the weight of the wall panel was equivalent to the value at 1/40 scale (0.78 g/cm^2). Based on the results, the wall thickness of the wall panel was 3 mm. On the back of the wall panel, crushed stone layer was set with 1 cm wide simulating the drainage layer on the wall, and backfill soil was set behind the crushed stone layer. The soil test results of the backfill soil are shown in Table 2, and the grain size distribution of backfill soil is shown in Fig. 5. About 95% of the backfill soil consisted of fine sand and medium sand. The shear strength of backfill soil was estimated only in angle of shear resistance, the grain size of the backfill soil did not consider model scale. The compaction of the backfill soil was carried out so that the relative density had reached $D_r = 90\%$ according to the result of the test for maximum and minimum densities. This relative density is one of the standard value of compaction degree of road embankment in Japan (JRA, 2010). For the crushed stones layer, gravel with a maximum particle size of 3 mm was sieved with 2 mm sieve and an equalized material with a particle size of 2 mm to 3 mm was used. The grain size of crushed stone was chosen to flow out from clearance of the wall surface panel which is intentionally made as one of the test cases. Moreover, a nonwoven fabric was laid between the backfill soil and the crushed stone layer for preventing backfill soil from flowing out.

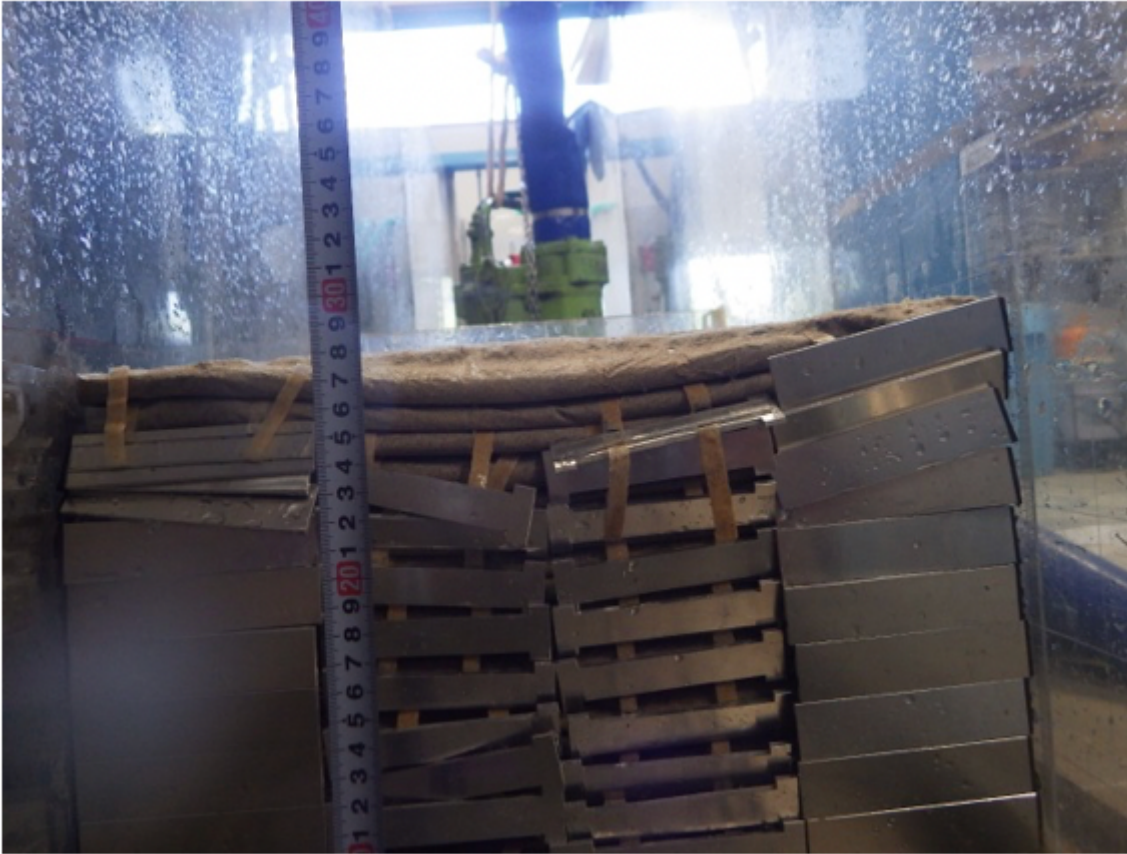
Condition of front panel after draining (CASE-2)

Around 30 minutes after the start of the tsunami action, the wall panel showed gradual deviations such as slippage. Figure 15 shows the condition of front panel after the first tsunami action. At the end of the tsunami, almost all the crushed stone at the backside flowed out and pulling out panels were confirmed until the third stage from the top. Although the maximum amount of settlement at the top end of the reinforced soil wall was seen to be 2 cm at the center (80 cm at the actual scale), since it is supported by the nonwoven fabric laid as prevention material of the back-filling material draw-out; in fact, the significant collapse could have occurred.
