A Polishing-free Etching Method for Microstructure Observation of Fine-grained Ceramics

Rapid Communication

Keywords: fracture surface, ceramics, etching, SEM

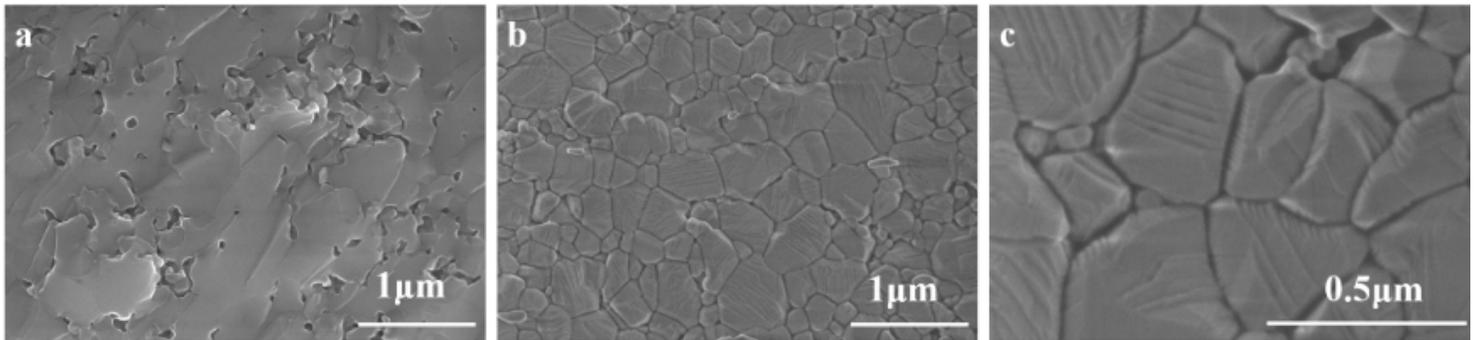
Micrographs of MgAl₂O₄ ceramics. (a) Fracture surface; (b) and (c) Thermal etched fracture surfaces.

Figure 1 shows the microstructure of the MgAl_2O_4 ceramic sintered at 1420 °C for 3 h. Panels include micrographs of fracture surface (a) and thermal etched fracture surfaces (b) and (c). In Fig. 1 (a), the fracture surface is almost flat with no contrast between the grains and grain boundaries. Obviously, the as-sintered MgAl_2O_4 ceramic fractured in an intergranular fracture mode. Traditionally, polishing and etching processes are required for ceramics fractured in this mode before observing the microstructure. However, in this process, machining through grinding or polishing were not needed due to the previously formed flat surface after fracturing. In Fig. 1 (b) and (c), clear grain boundaries can be distinguished after directly thermally etching the fractured surface. Grain sizes were distributed on a scale of 50–500 nm; all were imaged successfully. The original pores after etching are still similar as that in Fig. 1 (a). In summary, the as-prepared fine-grained MgAl_2O_4 ceramic described here has grains small enough to be totally imaged on the micrometer scale by SEM. As a result, the machining step was diminished, and the etching process proceeded directly on the fracture surface. The simplified sample preparation method is not only time-saving but can also protect the original microstructure from damage during machining.

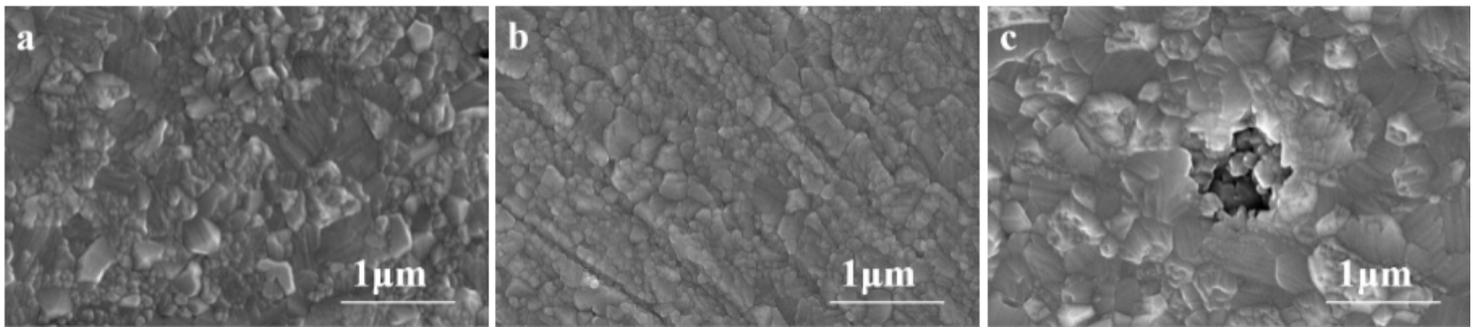
Micrographs of a thermally etched polished surface of MgAl₂O₄ ceramics. (a) Misled small grains; (b) Scratches on the surface; (c) Pore-like flaws.

On the contrary, if the machining processes such as grinding or polishing were followed, then all destructions such as scratches and pullout grains may occur. Figure 2 shows the three typical destructions on the microstructure of the MgAl_2O_4 ceramic that resulted from polishing and etching. Surprisingly, Fig. 1 and Fig. 2 were SEM pictures taken from the same sintered MgAl_2O_4 ceramic, but they appear completely different. In Fig. 2 (a) and (b), many grains as small as 30 nm or less are shown. However, the actual grain sizes are distributed between 50 nm and 500 nm. As against the same ceramic sample shown in Fig. 1, one sees that the machining and etching processes on the ceramic surface in Fig. 2 resulted in some misleading phenomena such as ultra-small grains. The abrasive particles might be left on the ceramic surface after polishing.

Fig. 2 (b) shows obvious scratches that resulted from grinding. These affect the imaging quality and the calculated average grain size. Fig. 2 (c) shows a single pore with a size of about 1 μm . This is several times bigger than the average grain size. During grinding and polishing, some grains may be pulled out due to the weak grain boundaries; the pore-like information is then detailed on the SEM picture. The large pore in Fig. 2 (c) may result from the grain pullout during machining. These types of damage (false ultra-small grains, scratches, etc.) are barriers for researchers and obscure the true features of the ceramic microstructure.

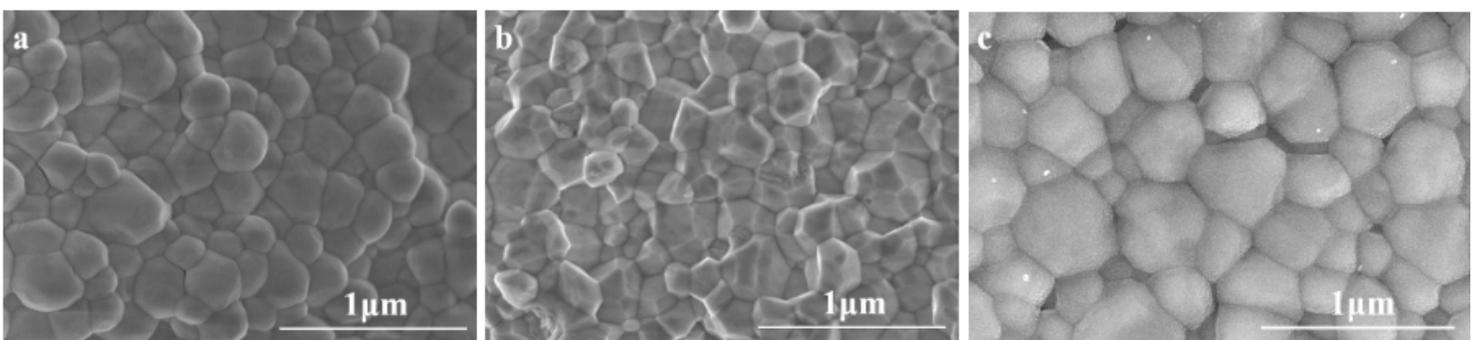
Micrographs of ZrO₂ ceramics. (a) Thermal etched fracture surface; (b) As-fractured surface; (c) Polished and thermal etched surface.

Figure 3 (a) shows the thermal etched fracture surface of the ZrO_2 ceramic. No pore can be identified here because the ZrO_2 ceramic was pre-sintered first, and then HIPed at 1260 °C for 3 h with 200 MPa argon pressure. The ceramic was fully densified. The grain boundaries after grooving by thermal etching are more distinct than without etching [Fig. 3 (b)]. Comparing the two micrographs from the different pre-processing steps suggests that although the etched fracture surface shows better contrast, it somehow changes the original state of the fracture surface. Clearly, the edges and corners of the grains in Fig. 3 (a) were erased via thermal etching. Nevertheless, the micrographs obtained from the fracture surface with or without etching processes were better than Fig. 3 (c), which resulted from polishing and etching processes. Although it seems that no obvious destruction occurred on the microstructure of the ZrO_2 ceramic, some white impurities do remain on the surface. In summary, the etching process on the fracture surface may not be necessary for ceramic fractures just along the grain boundaries or in cases with clear grain boundaries.

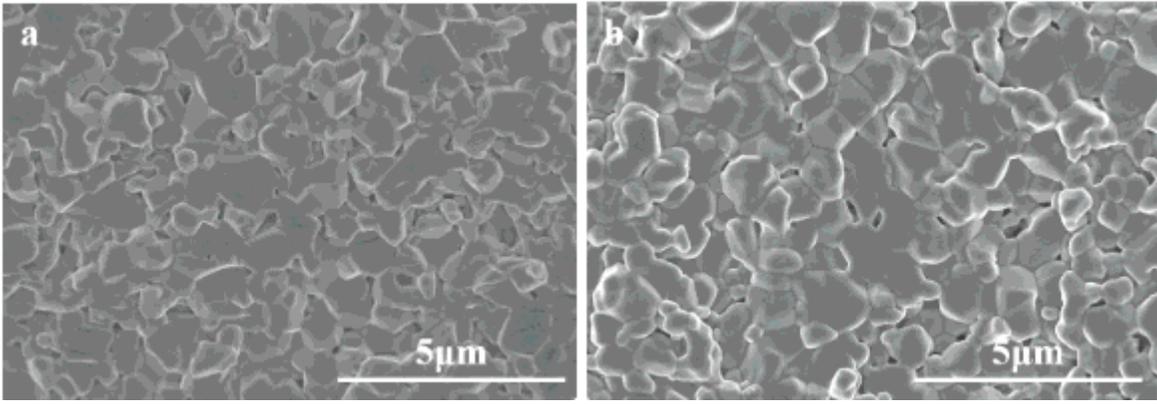
Micrographs of Al₂O₃ ceramics. (a) As-fractured surface; (b) Thermal etched fracture surface.

However, not all ceramics fractured in a transgranular mode show clear contrast between the grains and grain boundaries. In this case, proper etching processes are necessary before SEM observation. For example, the alumina ceramic fractures in a transgranular fracture mode, but the contrast between the grains and grain boundaries is low. Figure 4 (a) and (b) show SEM pictures of an as-fractured surface without etching and a thermal etched fracture surface of the alumina ceramic, respectively. Obviously, the pores observed from Fig. 4 (a) and (b) were very similar. Figure 4 (b) shows better contrast between the grains and grain boundaries due to the glassy phases or impurities that were erased by etching.
